**Engineering Assessment of Two Cylinders Observed at the Douma Incident****- Executive Summary**

Expanded Rev 1 - 27 February 2019

1. This note relates to the incident of alleged use of toxic chemicals as a weapon in Douma on 7 April 2018 in the Syrian Arab Republic.
2. As part of the fact-finding mission, information was gathered and assessed on two chlorine cylinders, observed at two separate locations in Douma. The FFM team visited both these locations:

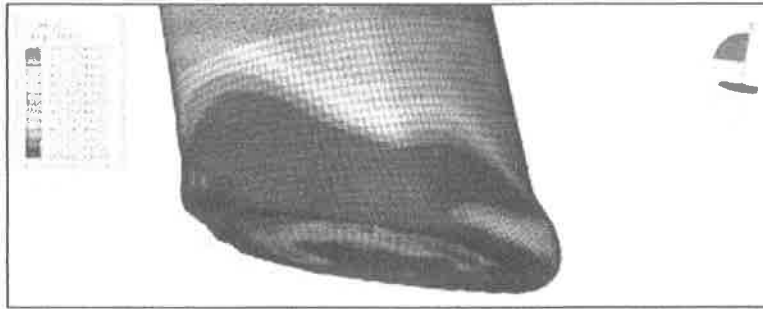
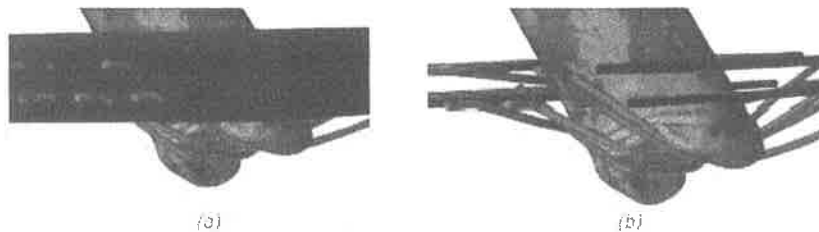
Figures 1 & 2 (above): Predicted deformation; initial and final computational analysis

22. As mentioned above, the predicted cylinder deformation was not consistent with that observed on the cylinder observed at the scene at Location 2. The results predicted from the simulation were more consistent with images of deformed cylinders from earlier incidents of cylinders allegedly delivered from helicopters in the Syrian Arab Republic.

Figure 26: Final frame simulation of the impact of a vessel with an initial velocity of 100m/s.  
(a) complete model and (b) visualization without concrete

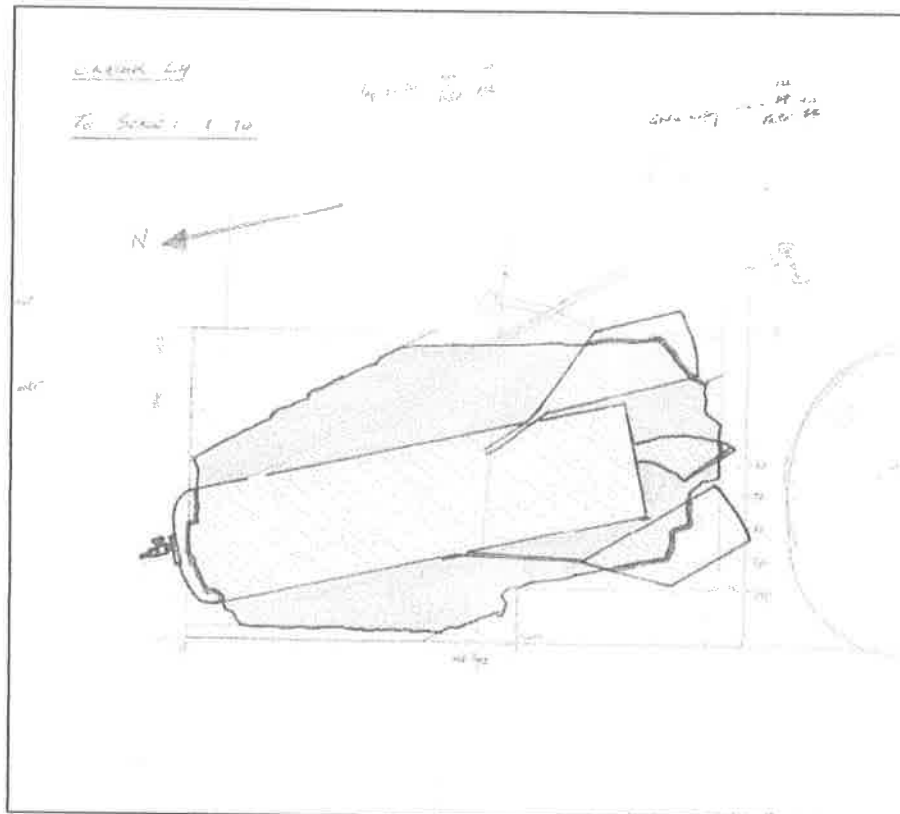
27. In the scaled dimensional analysis on the Location 4 cylinder, pre- and post-deformation, compared with the crater in the roof, it was not possible to establish a set of circumstances where the post-deformation cylinder could fit through the crater with the valve still intact (whether or not an end-cap was assumed to have been fitted at the front end of the cylinder), and the fins deformed in the manner observed. The observed deformation of the cylinder and direction of apparent inertial deformation of attachments, were clearly consistent with a cylinder having impacted in a flat configuration on a horizontal surface, and not that of a cylinder having penetrated through a crater.

Figure 9: Location 4 cylinder post-impact superimposed onto crater (baseline configuration, for illustrative purposes). Sketch from a scaled drawing

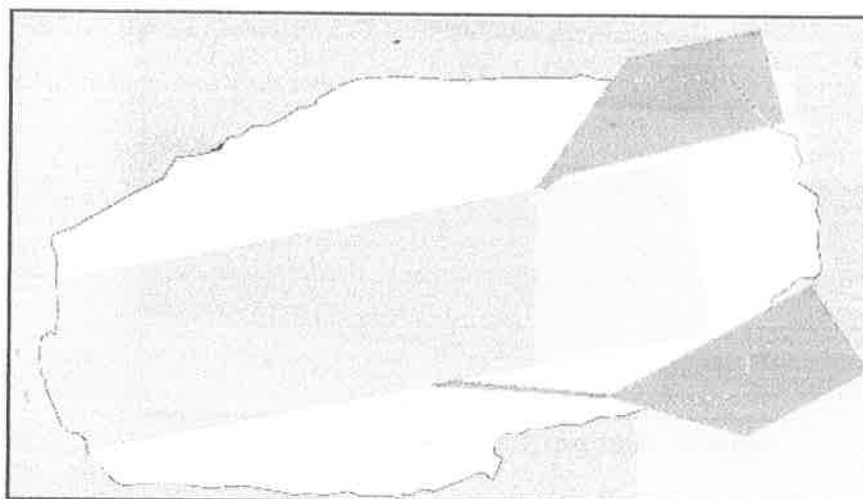
Figure 10: Location 4 cylinder post-impact superimposed onto crater, from dimensional model
